ANALYSIS AND OPTIMIZATION OF H-13 FORGE STEEL DIE MATERIAL FOR BULK PRODUCTION

Abstract: The properties of H13 are dependent on the microstructure, the composition, and the heat treatment. The microstructure of H13 steel is composed of a tempered Ti C matrix, with various alloying element carbide precipitates distributed within. These carbides are composed of molybdenum, vanadium, chromium and iron. The size of the carbides varies for each alloying element that composes it. The molybdenum and vanadium carbides tend to be larger in size and clustered together. Carbides, composed of iron and chromium, are distributed evenly and therefore are very fine and do not form clustered colonies. The size of the carbides plays a key role in fracture. The present work discuss the life feasibility of the die by practical way of observing micro structures of bottom die after crack propagation and the hardness levels of heating. The process has been carried out on 1 ton hammer for observation of load impacts on the die.

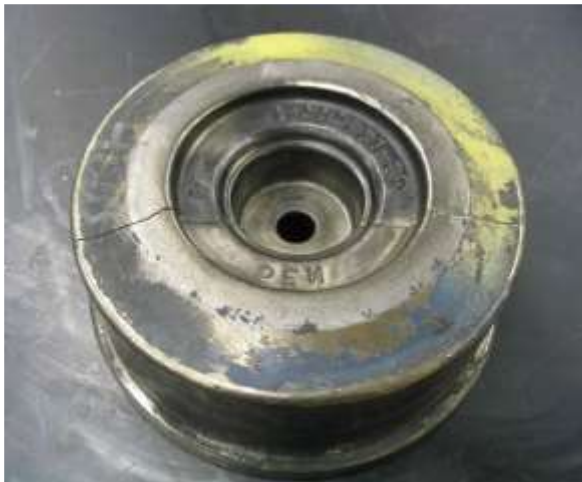
The manner in which each of the failed dies fractured was identical. Figure below is a representative photograph of the appearance of the fractured dies. The failures appeared to have started near the center radius of the die and propagated outward.

dies were nearly broken into two pieces by the failures

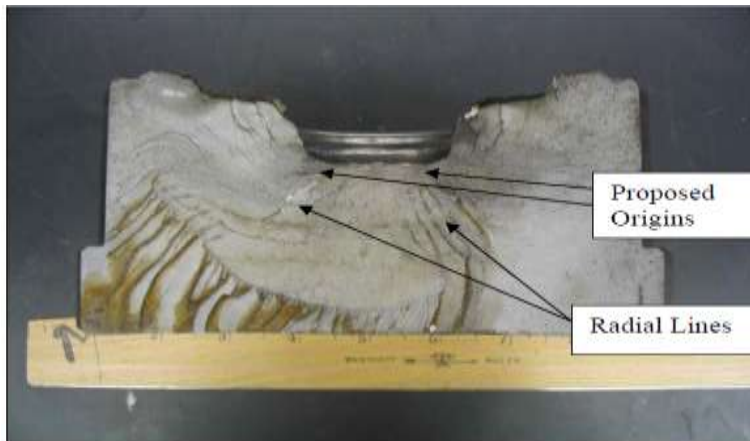
This observation yielded little information about the cause of failure. Therefore, the failures were propagated using a hammer to allow examination of the fracture surface. The fracture surfaces contained very useful morphologies that enabled conclusions of the origins of failure to be made, Figure Inspection of the fracture surface under the stereomicroscope and with the naked eye revealed no signs of fatigue. The failure appeared to be brittle in nature, which was expected due to its high hardness, and to have occurred in a very few number of cycles. The radial lines on the surface pointed to the source of failure as being near the center radius of the die.

Photograph of die A fracture surface with origins and radial lines marked

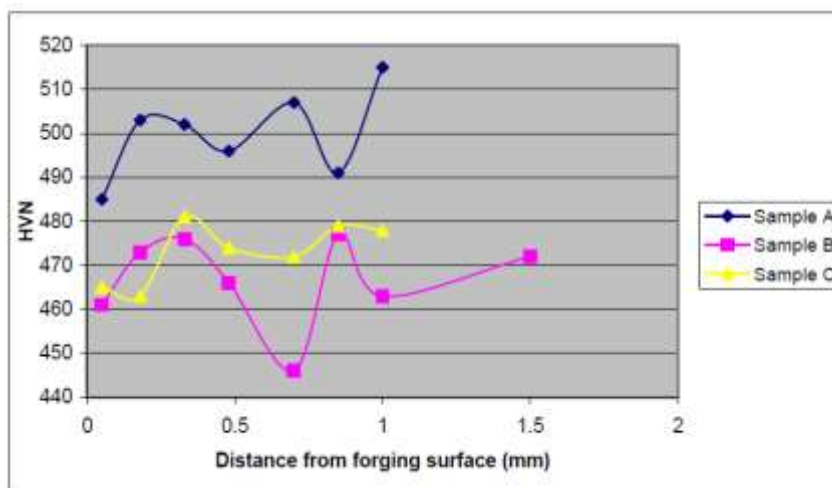
Micro-hardness measurements were then taken on several of the pre-hardened dies (dies A, B, and C) at the forging surface in order to determine the presence of decarburization or work hardening. Either of these two phenomenon would have a dramatic effect on the surface properties of the dies. No signs of any defects were found on any of the samples as can be seen by Figure.

Micro-hardness traverse measurements yielded no signs of defects

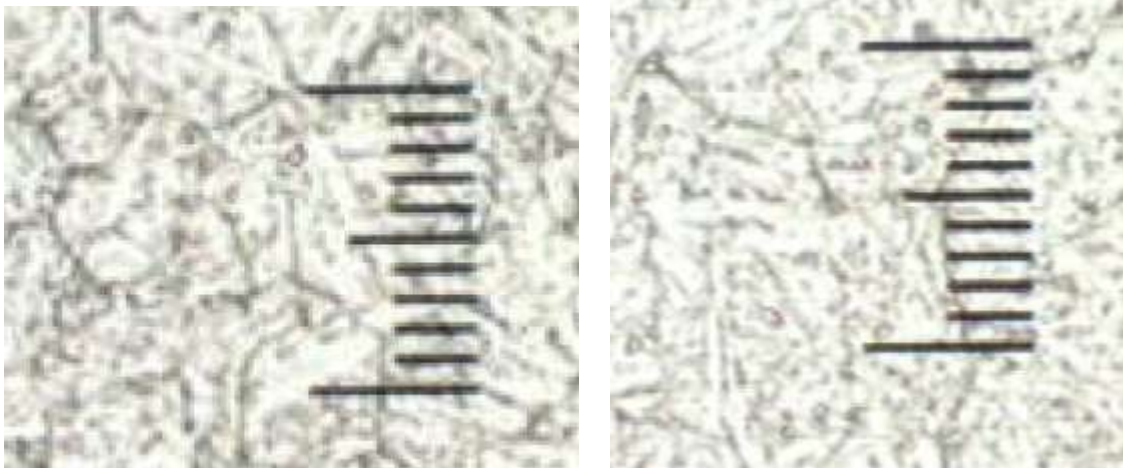
Microstructural comparison was performed between all samples. The microstructures of all specimens were nearly identical; however, the microconstituents of the vacuum heat treated material appeared slightly finer than the pre-hardened material. This finer microstructure was thought to denote the difference in heat treatments and/or alloying elements.

Micrograph of die A & H revealing micro constituents present (2% Nital, Scale bar 20 μ m).

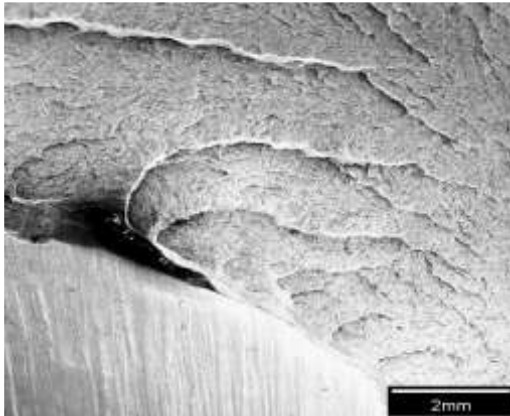
Fracture Surface Analysis: Scanning electron microscopy was performed on two of the failed dies, A and E, to determine the mode(s) of failure and the precise initiation points. It was not possible to find the exact initiation point of each failure due to the large number of origins and some post-failure damage. However, some large oxide inclusions were found near the center radius of the die where the failure was believed to have initiated, Figure. There were river marks radiating out from these oxides which revealed they contributed in some manner to the initiation or propagation of the failure.

Micrograph shows presence of oxide inclusion near failing radius.

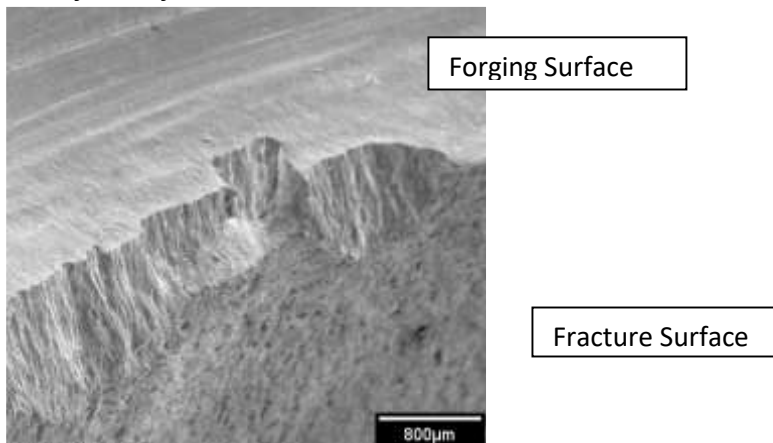
The fracture surface was characterized to be a brittle type failure with no signs of fatigue, the failure mode was found to be low cycle, high stress fatigue from the morphology of the fracture surface. Due to the extreme forces applied to the dies, the fracture propagated to complete failure in very few cycles.

Micrograph illustrates forging/fracture surface interface on die E.

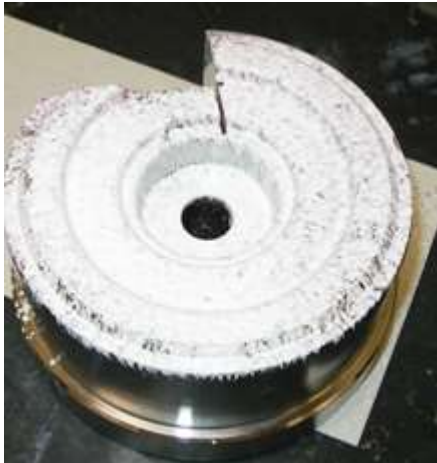
To find whether or not this or any cracks existed in the die, a dye penetrant test was used. The test revealed no signs of cracks on the machined surface.

Cracks would appear as red lines on the white background

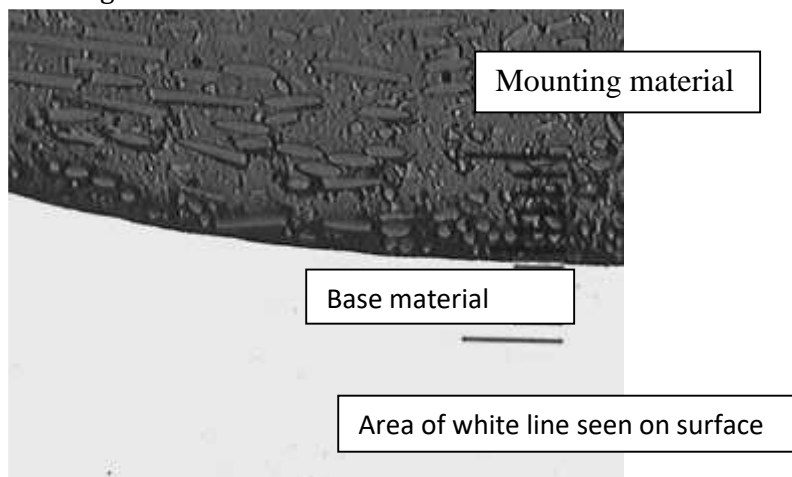
The die was next sectioned through the unknown line and prepared metallographically. This determined the depth of the scratch and also fully ruled out the presence of any type of crack. Figure shows that no signs of cracks, scratches or even deep grooves exist where the white line was. The line was then determined to be a light scratch on the surface of the die, possibly from handling.

Micrograph shows no signs of any large surface defects were found, scale bar 200 μm

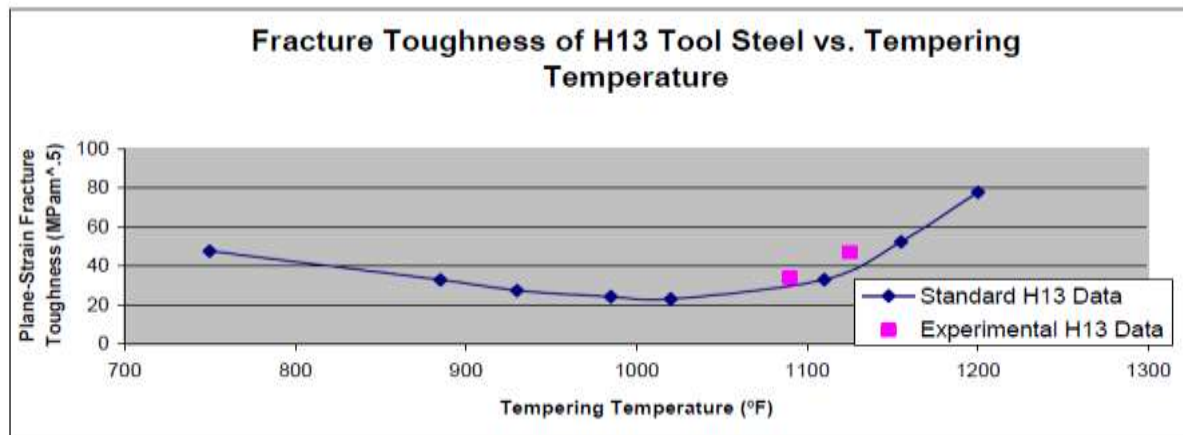
Fracture Toughness Analysis : Fracture toughness testing performed has shown the vacuum heat treated stock to have a higher fracture toughness value, $47 \text{ MPa}\sqrt{\text{m}}$. The fracture toughness value for the pre-hardened stock was $34 \text{ MPa}\sqrt{\text{m}}$.

The graphical relationship between fracture toughness and tempering temperature for H13 steel are plotted for standard and experimental data.
